Brahmaputra river in India : an analytical study with special reference to its erosion.

Arvind Phukan¹, Rajib Goswami², Deva Borah³, Ananta Nath⁴ and Chandan Mahanta⁵

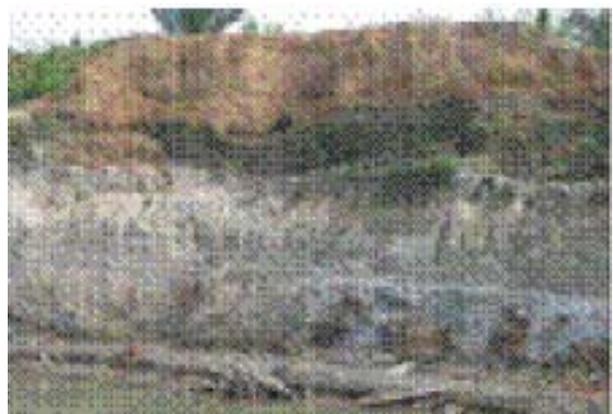
Fig. 5 : River Bank Failure of the Brahmaputra River at Rohmori, Assam

migration of thalweg closer to the bank during the falling stages (Coleman, 1969). The bank materials in the Brahmaputra are highly susceptible to erosion by the river due to their high moisture content, low clay content and poorly graded fine sand and silt. Photographs of typical river bank failures at selected locations of the Brahmaputra River are presented in

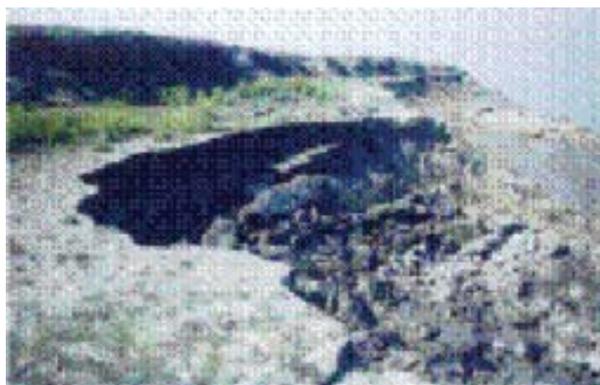
Fig. 6 : River Bank Failure of the Brahmaputra River at Neamatighat, Jorhat District, Assam
